**REMEDIAL WORK FOR THE COLLAPSE OF MONSOON DRAIN ALONG
LEBUHRAYA DAMANSARA-PUCHONG, 2000**

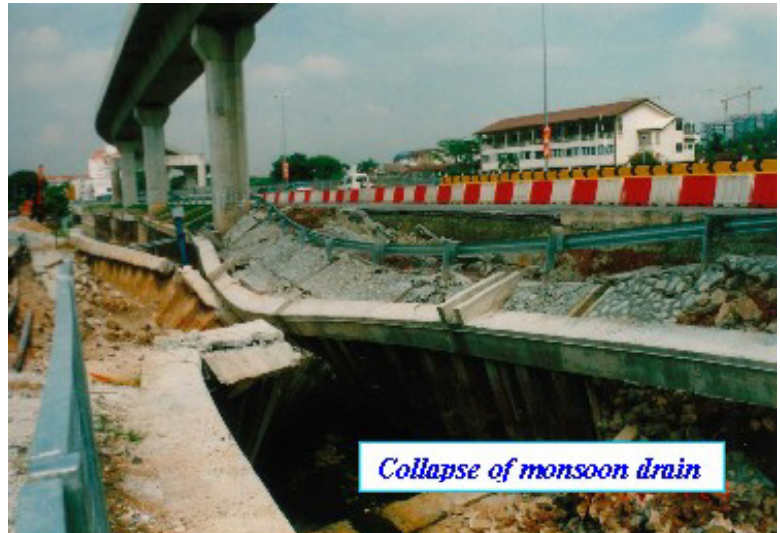
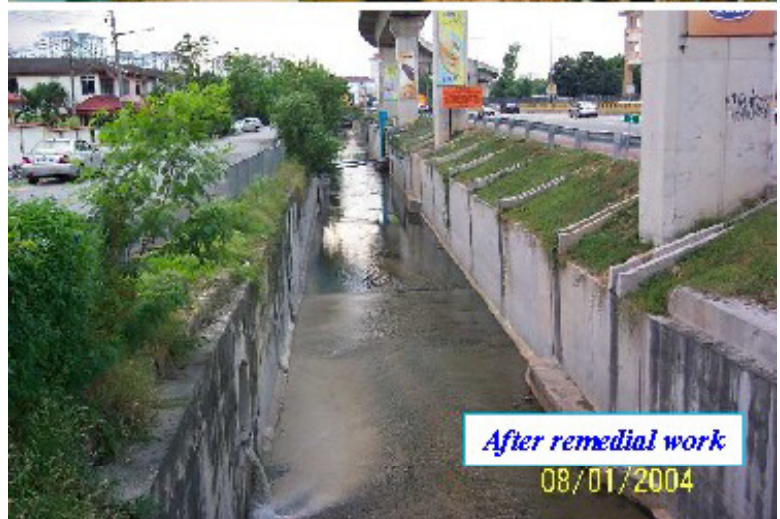
The monsoon drain was originally constructed using two rows of cantilever sheet piles to retain the soil on both sides. More than 30m long stretch locating downstream of a triple cell box culvert collapsed after a series of heavy rains. Temporary remedial measure was carried out immediately by installation of two rows of sheet piles with one level of internal strut.

Investigation was carried out. The subsoil mainly consisted of very loose to medium dense sandy materials. Very dense sandy soil was at about 5 to 6m below ground surface. Granite bedrock could be found at depth of about 8m. The collapse was likely due to bed scouring taken place at because the bed was not protected by concrete slab. The scouring caused the loss of resistant forces in front of the sheet piles. In addition, groundwater level trapped behind the sheet pile wall took longer time to lower could have contributed additional force to the sheet pile wall.

Few remedial options had been evaluated. Concrete U-shape drain was selected. It was economical and long-term performance could be ensured. The remedial work commenced in December 2000 and took 6 months to complete.
